Assessing and Monitoring Permafrost along the Dempster Highway: Paving the Way for an Adaptation Strategy

Fabrice Calmels¹, Louis-Philippe Roy¹, Kate Grandmont¹,
and Sandra MacDougall²

Dempster Highway, Yukon

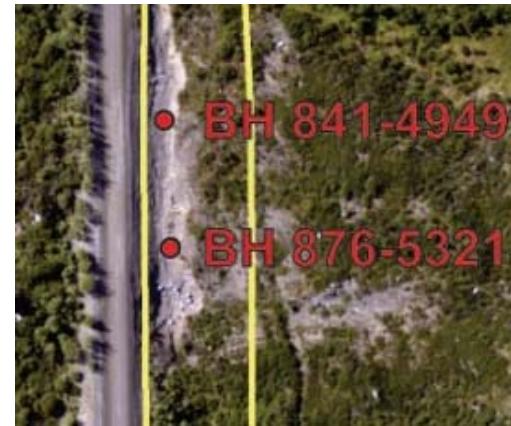
Borehole 841-4949

No massive ice observed
Depleted in fine material
Thermal impact at freshet
